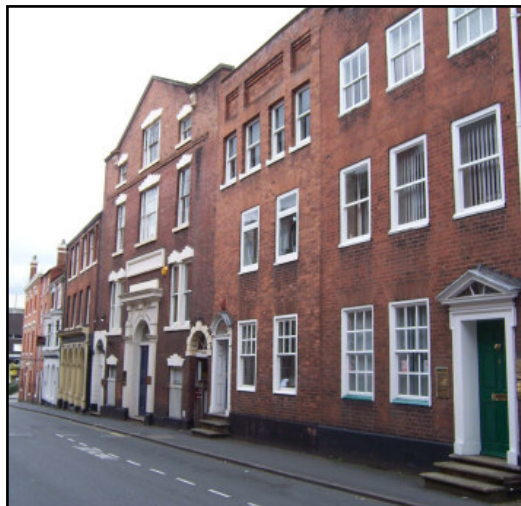
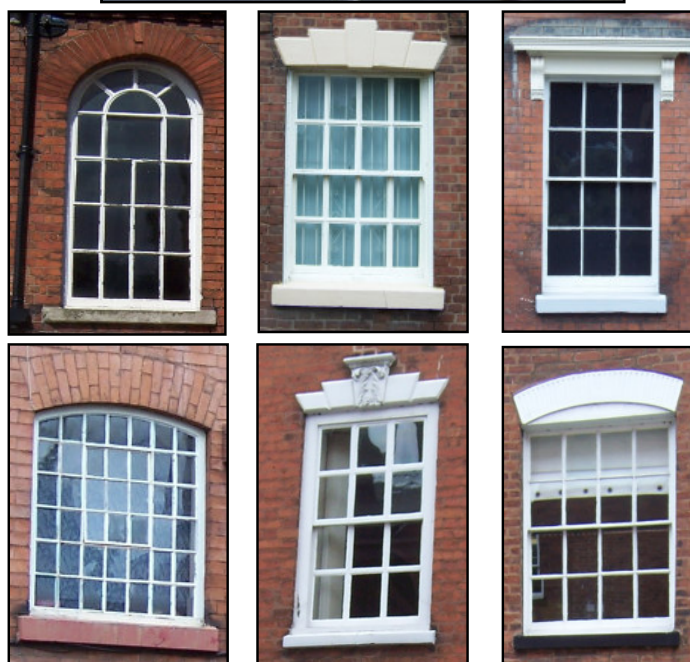
b) Windows

Windows provide a highly important contribution to the character and appearance of the Area. The contribution is not down to a specific type of window as there are a variety of types including hung sashes with and without glazing bars, plain transomed-mullioned casements, arched windows, gabled dormers. Instead the fenestration is important for providing a particular rhythm and sense of proportion to the overall street scene which is highly important to the aesthetic appearance of the Area. Where this pattern is broken, such as No 26 Church Street, it jars against the street scene.

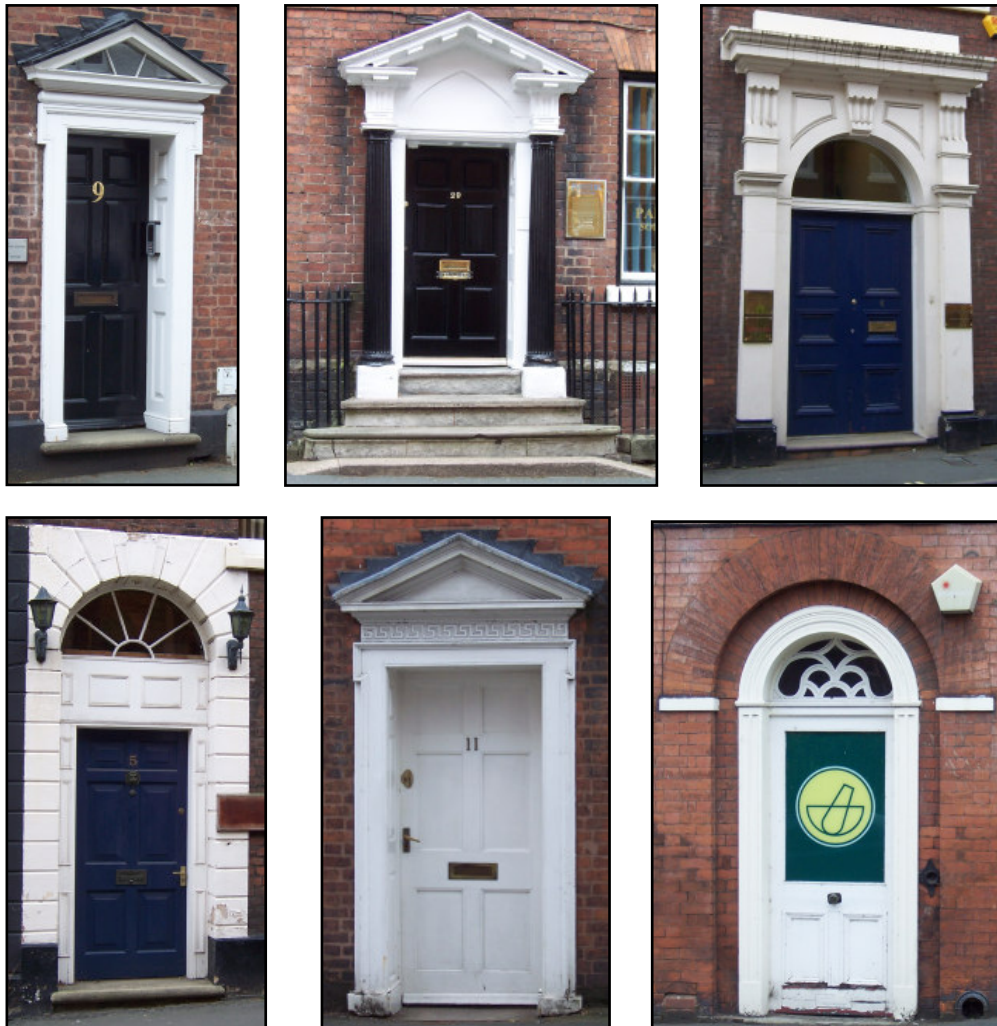
c) Doors

The doors and their surrounds are an important feature of the Area. The doors are predominantly unglazed with wooden panelled doors the norm. There is a mixture of both recessed and raised panels. The number of panels per door vary although there are a number of examples of the classic Early Georgian arrangement of 6 panels, with the top two far smaller than the middle two, which are themselves slightly taller than the bottom two elevation.

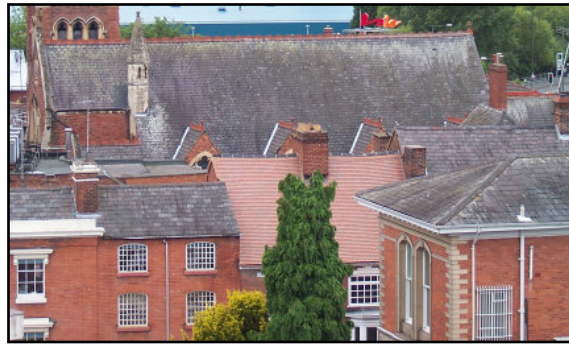
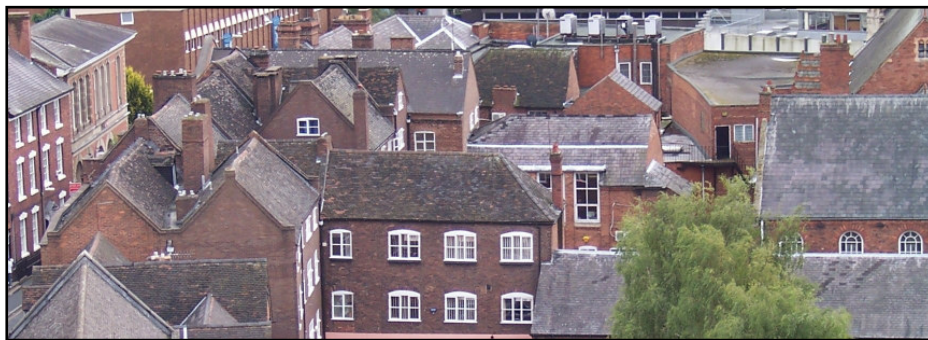
From within the Area it is difficult to see the roofs of the buildings. Some roof are hidden behind parapets. From other vantage points however views across the roofscape can be gained and these reveal that the roofing materials vary between tile and slate. Colours range from grey to a reddish brown.

Most of the roofs are gabled, the pitch of which are generally steep, varying between 40 and 45 degrees. There are also examples of hipped roofs. Flat roofs are also present covered in a grey roofing felt. Whilst such roofs are in the minority they do detract from the character of the historic roofscape.

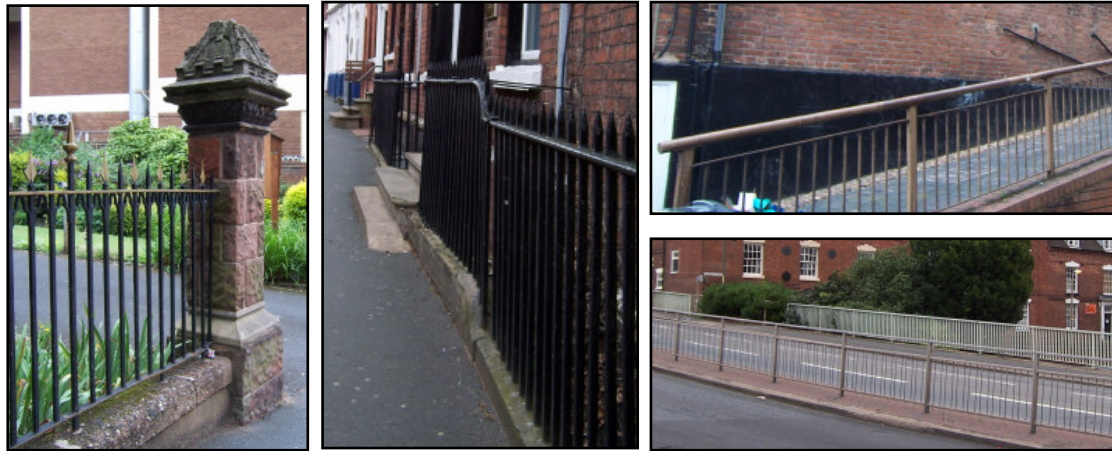
f) Boundary walls, copings and railings

Railings are a feature of the Area that add significantly to its character and appearance. These range from the traditional, such as those outside Nos 29 and 30 Church Street, to modern replacements such as those outside Nos 22-25 Church Street. Historic photographs show the railings that were present in the early part of the twentieth century.

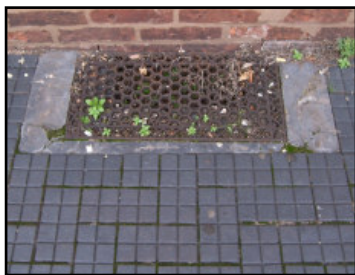
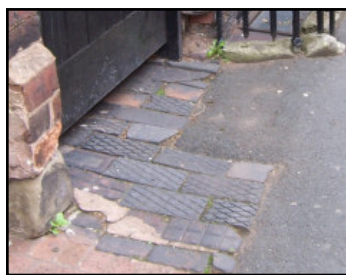
and the majority of the pavements. “Black top” has also been used for the car park at the north end of Church Street, and in part for the drive ways of the New Meeting House and in front of the Baxter Sunday School. This is a non-traditional material and does not contribute to the character and appearance of the conservation area. Repairs to the tarmac have left it looking untidy and it detracts from the historic street scene.

Church Street and on Arch Hill. Wire cut paviors are present on the driveway to the New Meeting House. Some of the buildings have passageways giving access to the rear of the properties, and some of these retain old paving setts of interest. Ornate metal grilles can also be found in the pavement.

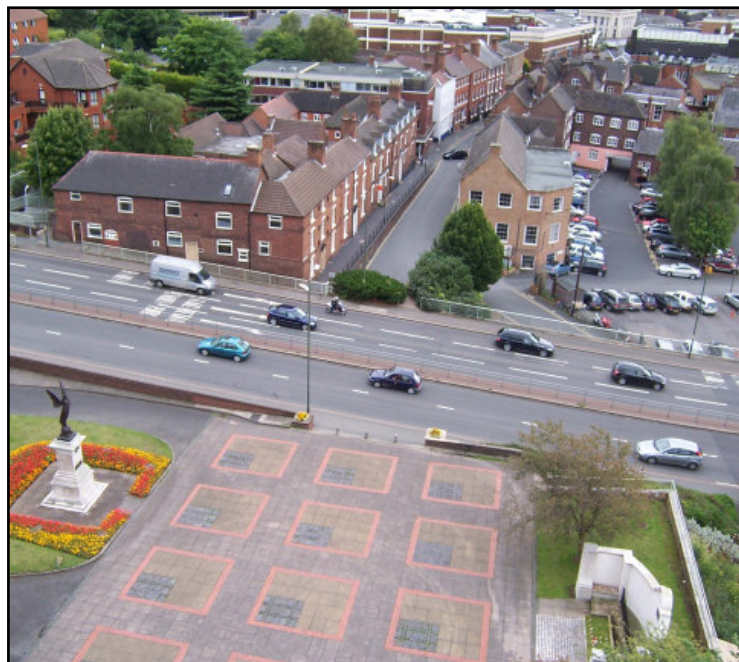
- The setting. Although the following are not within the Area their close proximity has had an impact on the setting of the Area;

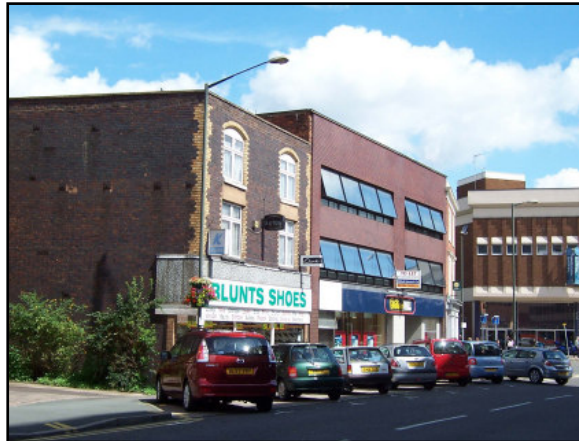
- Inappropriate modern development within the Area. For example;

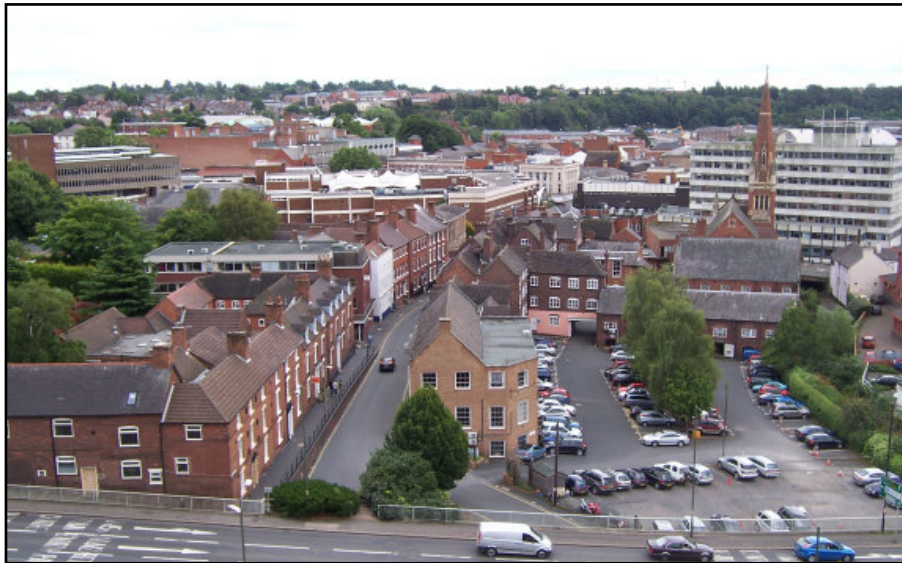
The car park at the north west of the Area is considered to be a neutral area. The site covers a considerable area and much of the site is covered in tarmacadam. Historic maps
